Emniyet Bülten No: 2020-02
Bülten Revizyon No: 00
Tarih: 29-04-2020
Sayfa: 1 / 3

Uçuş Operasyon Emniyet Bülteni

Konu:	Hava Aracı Kazası
Kapsam:	Havayolu, Hava Taksi ve Genel Havacılık İşletmeleri
Referans:	18.03.2020 tarihli Ulaşım Emniyeti İnceleme Merkezi Başkanlığı'nın Nihai Kaza Raporu
Açıklamalar:	Uçuş Operasyon Direktifi ve Emniyet Bülteni Talimatı (SHT-OPS UOD/EB)'nin 6 ncı fıkrası kapsamında, bahse konu ciddi olay veya kaza ile ilgili tespit edilen tavsiyeler göz önünde bulundurularak yaşanan ve yaşanması muhtemel operasyonel konulardaki emniyet risklerini azaltmaya yardımcı olmak amacıyla yayımlanmıştır.

Olay tipi	: Kaza
Olay tarihi	: 11 Mart 2018
Olay yeri	: Shahr-e Kord (İran) yakınları
Hava Aracı Tipi/Modeli	: Bombardier CL 604 Challenger
Hava Aracı Tescil İşareti	: TC-TRB
Hava Aracı MSN'i	: 5494
Rota	: Sharjah (Dubai) – Atatürk ()

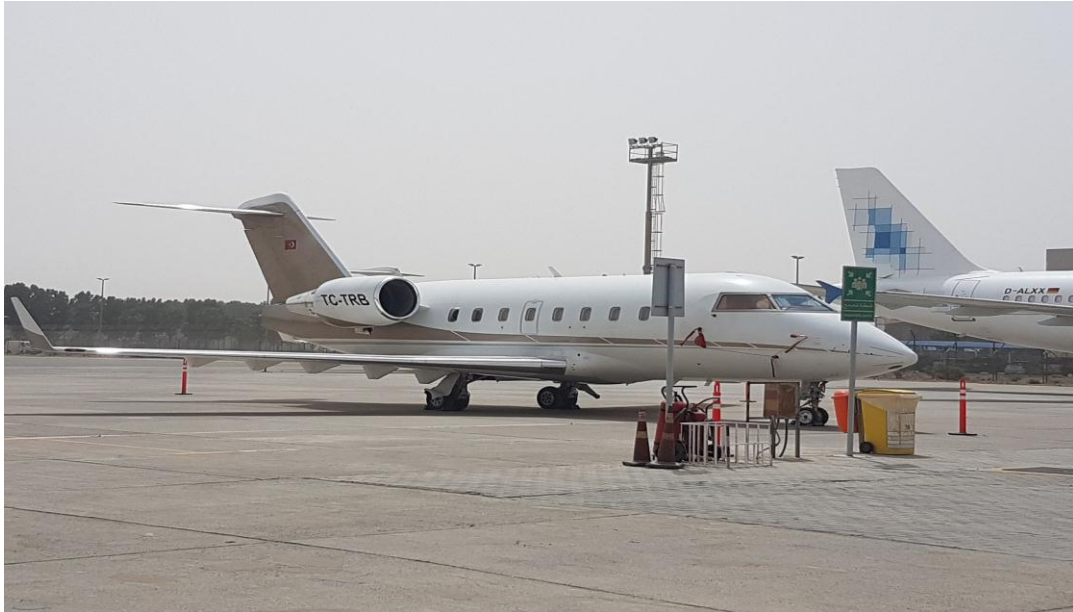
The aircraft had been parked for three days before flight in Sharjah International Airport. During the time, dusty weather condition was reported on the airport. A witness reported that initially crew did not set cover on Pitot tubes when aircraft was parked but picture of aircraft in parking showed that it was done later.

Park position of aircraft in Sharjah (OMSJ)

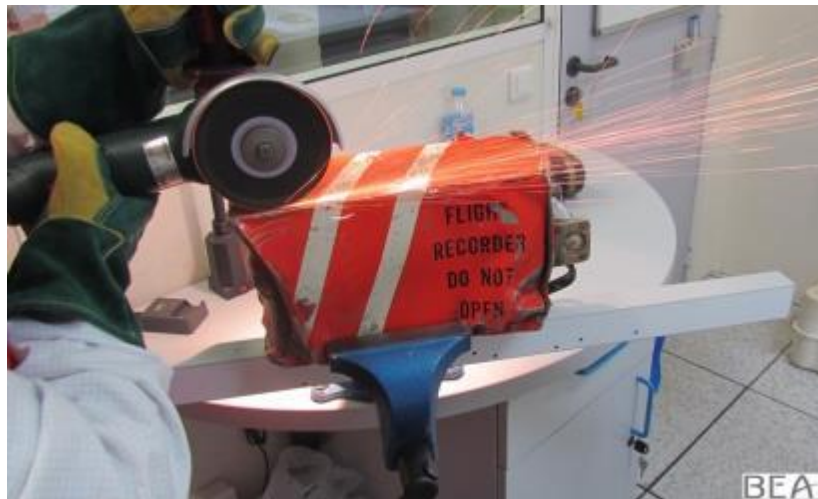
Due to the recorder's damage, the chassis was cut with electrical grinder to have a clear access to the main processor PWA.

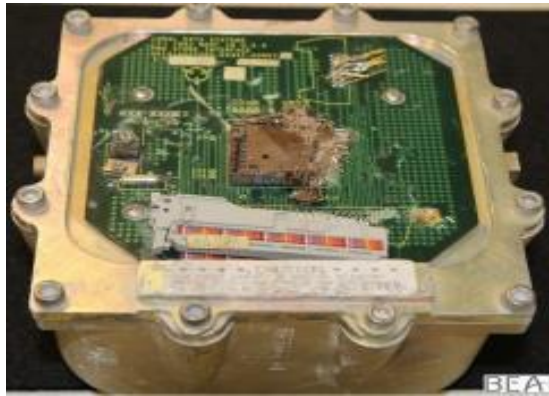
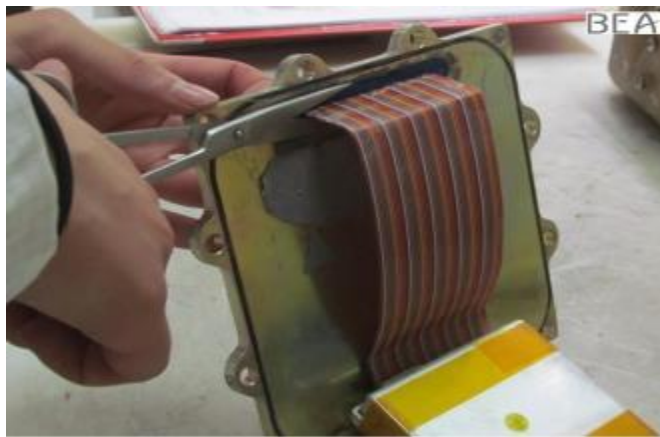
The FDR FCSSU was visually checked. The connector of the memory board was damaged.

The FCSSU was opened, the metallic casing of the memory board was extracted and the ribbon cable was cut close to the cover of the FCSSU.

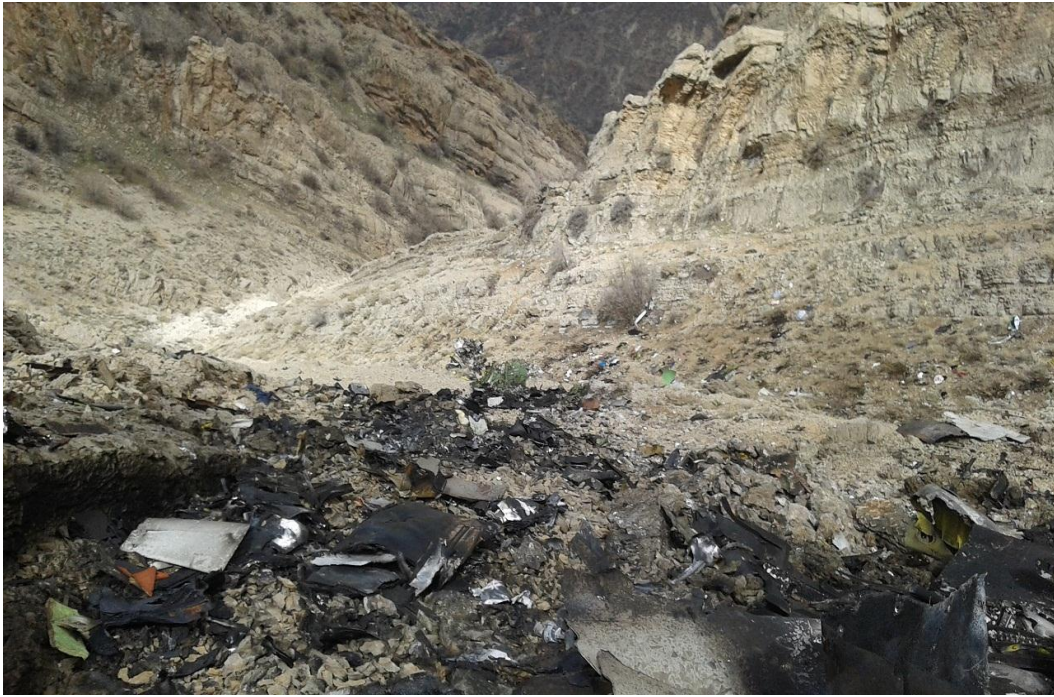
The investigation carried on Helen Mountain area along with the wreckage distribution pattern revealed that the initial contact with terrain has happened at an elevation of 7500 ft elevation, with the nose impacted first. As shown in the figures, the wreckage was scattered in an area of about 500 m long and 200 m wide on mountain slope. At the point of impact, there was a burned black hole about 3 m wide, 5 m long and 2 m deep. There was evidence of severe impact at this point with scattered parts from the cockpit, and nose section equipment of the aircraft. After the impact of the aircraft with the terrain, both engines were separated. Both engines were available at accident site and the condition of their rotating parts showed minimum engine rotation speed impact. The right and left wings as well as the forward fuselage including the cockpit, completely burned in the post-impact fire. It seemed that the aircraft had integrity before impact to mountain area.

Impact point and the wreckage of the aircraft

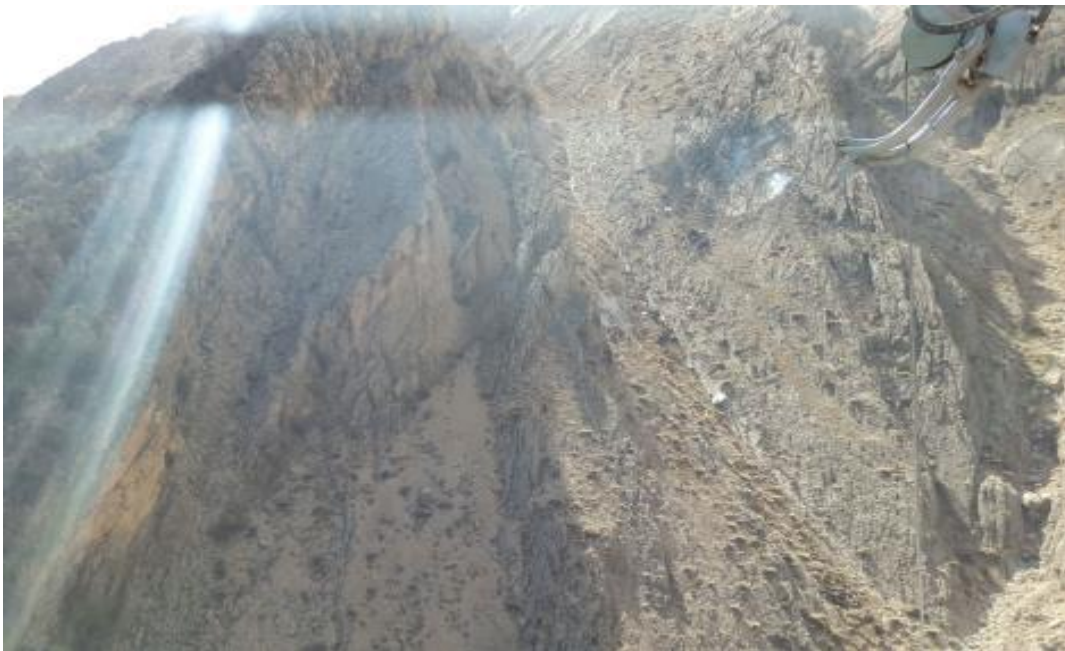
Impact point of the aircraft

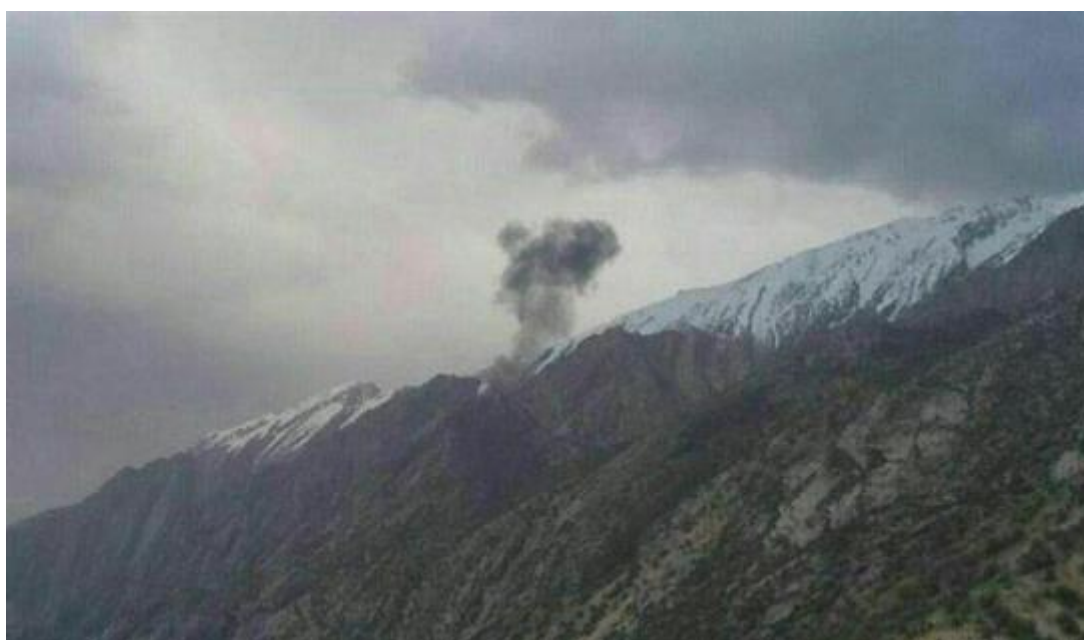
The first picture from crash site

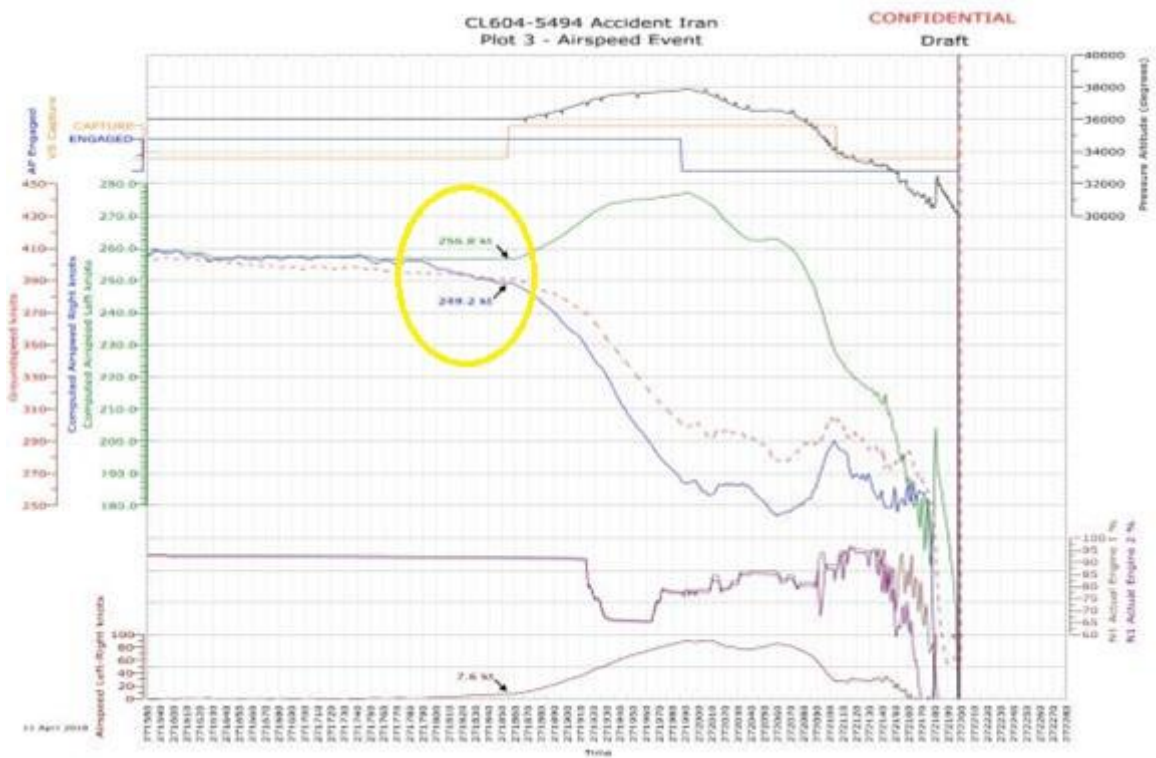
Accident flight

At 14:32 on FL360 the speeds of both side indicators began to diverge about 5 kt.

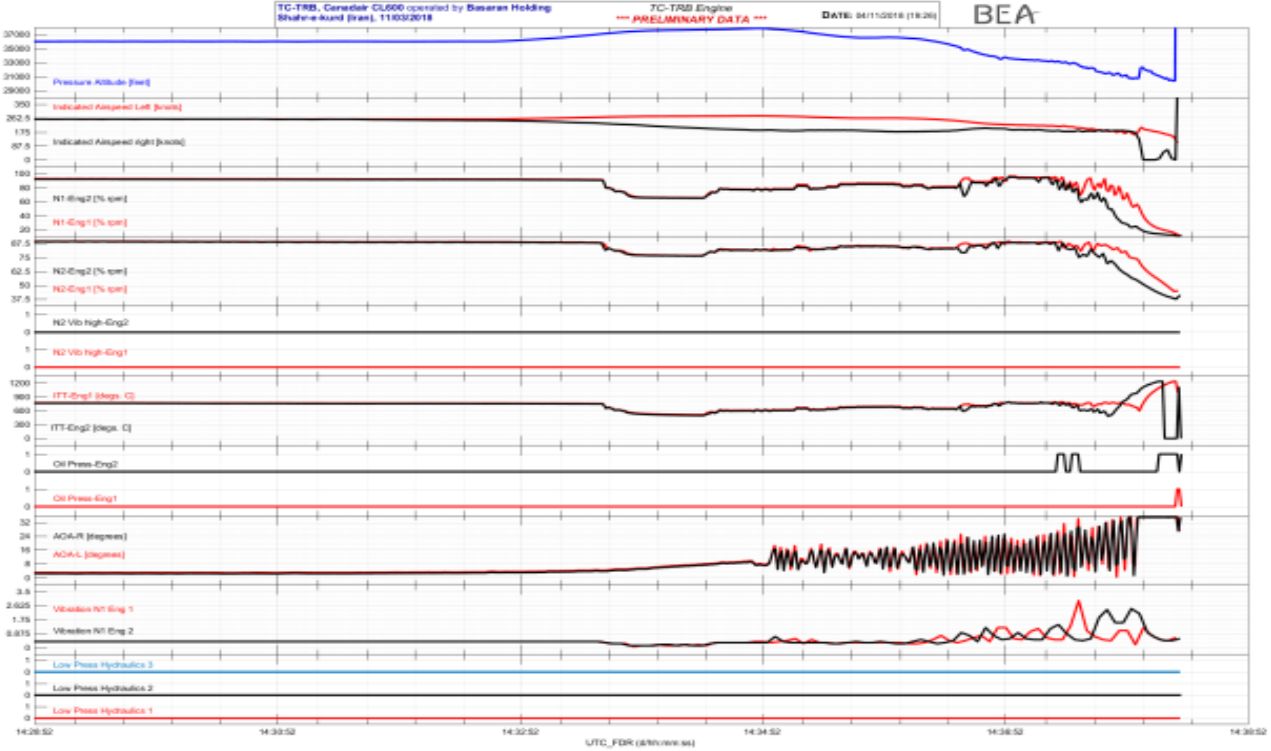
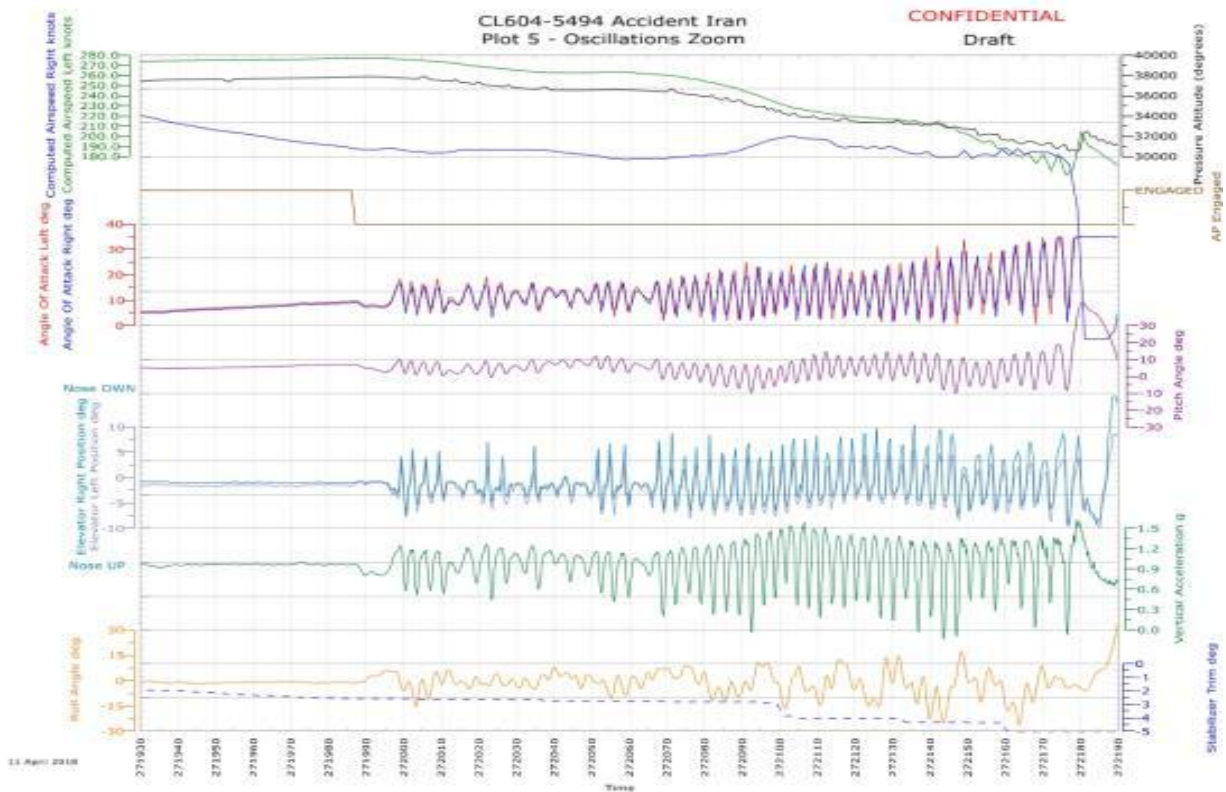
While aircraft was descending through FL370, the engine power and actual aircraft speed had reduced to stall speed but overspeed clacker was activated due to failure on indication system. The pilot never followed stall recovery procedures because she had a mind of overspeed by clacker warning [MMO over speed] on the cockpit. The stick pusher acted to pitch down aircraft to prevent stall condition but the captain's reaction on the control column just was in the opposite direction. During this time, the aircraft entered a series of pitch and roll oscillations.

The autopilot was disengaged by the crew before stall warning, which ended in oscillation of control surfaces based on FDR information. Engine power began to decrease on both sides until both engines flamed out in stall condition and FDR data recording was lost at this point. Data from the FDR shows that the aircraft experienced close to about 50 rapid pitch cycles following the activation of the stall protection systems, the result of the crew actively fighting against the pusher system.
